# Inspection Report Minerals Regulatory Program

Permit number: M/035/011

Mine Name: Copperton Concentrator (KUCC)

Operator Name: Kennecott Utah Copper

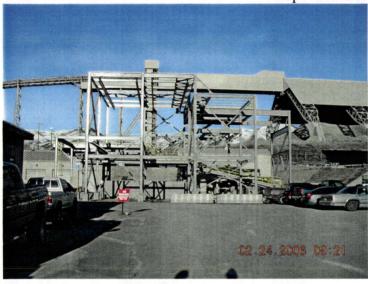
Red iron has been placed in the area where the surge tanks will be placed in anticipation of the placement of the pieces of the plant that will be placed in this area.

Photo 1 Support columns for surge tanks

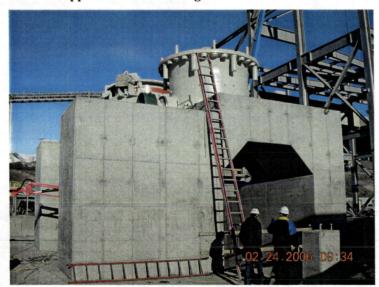
The concrete base for the gyratory crushers have been poured and the on concrete pedestals but work has not began to place a building around this area.

Photo 2 Pedestal and cone crushers

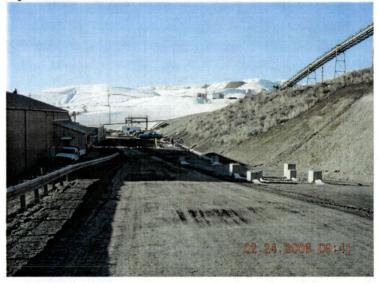
Concrete bases for the return belt to the concentrator have been placed but none of the support columns for the belt has been placed.

Photo 3: To the right—Concrete bases to support return belt
